Blijdorp Zoo

Rotterdam, Holland

VIP Quickspray Industrial &
QuickCoat – Base Protect

Case Study

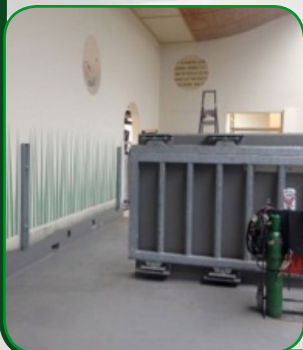
Following the evaluation of all of the alternative solutions proposed, a 2-component coating system based on VIP polyurea resin technology was selected. The 900m2 of concrete surfaces were prepared by blastcleaning, VIP QuickPrime Epoxy (solvent-free epoxy) was applied as a sealer and water vapour barrier, and then the VIP polyurea system was applied using hot airless spray techniques. An additional advantage of this system is that it can be successfully completed in a relatively short time, allowing other trades to continue and prevent delays so that it could open on time.
